## Docket No. 272 - Development and Management Plan Inspection

## **Segment 2a Inspection**

Date: September 28, 2006

Location: Segment 2a- Beseck Switching Station to Cheshire/Hamden Town Line

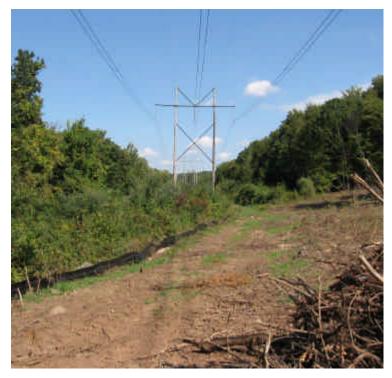
Erosion and sediment controls adjacent to the southern wetland at High Hill  $\operatorname{Rd}$ .

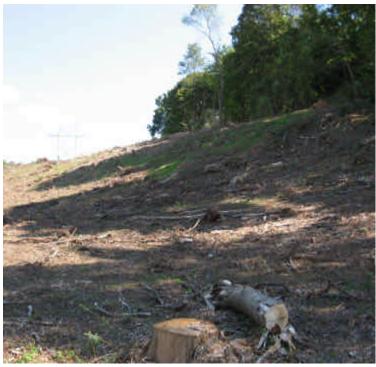
Recently seeded slope off High Hill Rd. Some grass growth visible.

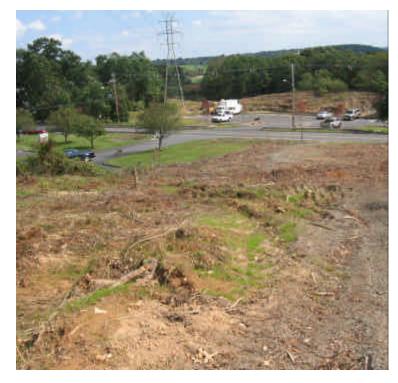
S. Turnpike + Merritt Parkway Area	Grass growth was noted on the steep slope. 9/28/06	Monitor slope until area is stabilized. 9/28/06	Grass growth noted.
	An existing riprap slope and culvert is present near the entrance from the road. No sediment	Continue to monitor and place controls in this area if traffic increases and adjacent soil becomes	NA

Some grass growth noted off South Turnpike

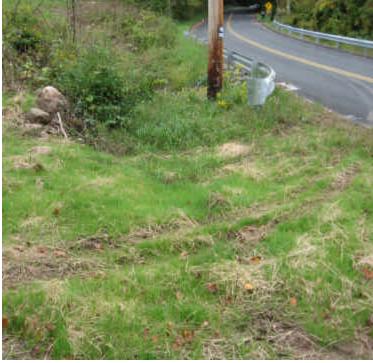
Grass growing well along Mansion Rd.

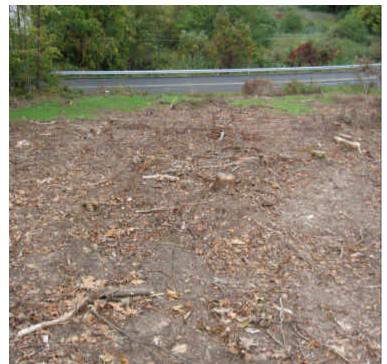
Roots left in place with grass growth downgradient on Mansion Road.

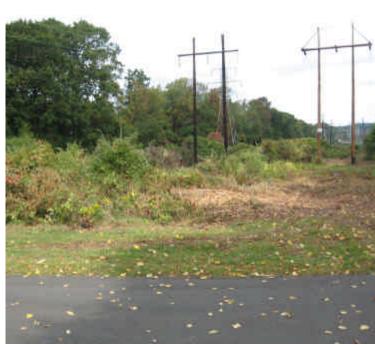
Careful, selective cutting noted along Old Farm Rd.
